Marine Survey Report For Mr. Mickey Mouse

"2022 Scout 425 LXF "

Date Of Survey: 7/23/2023

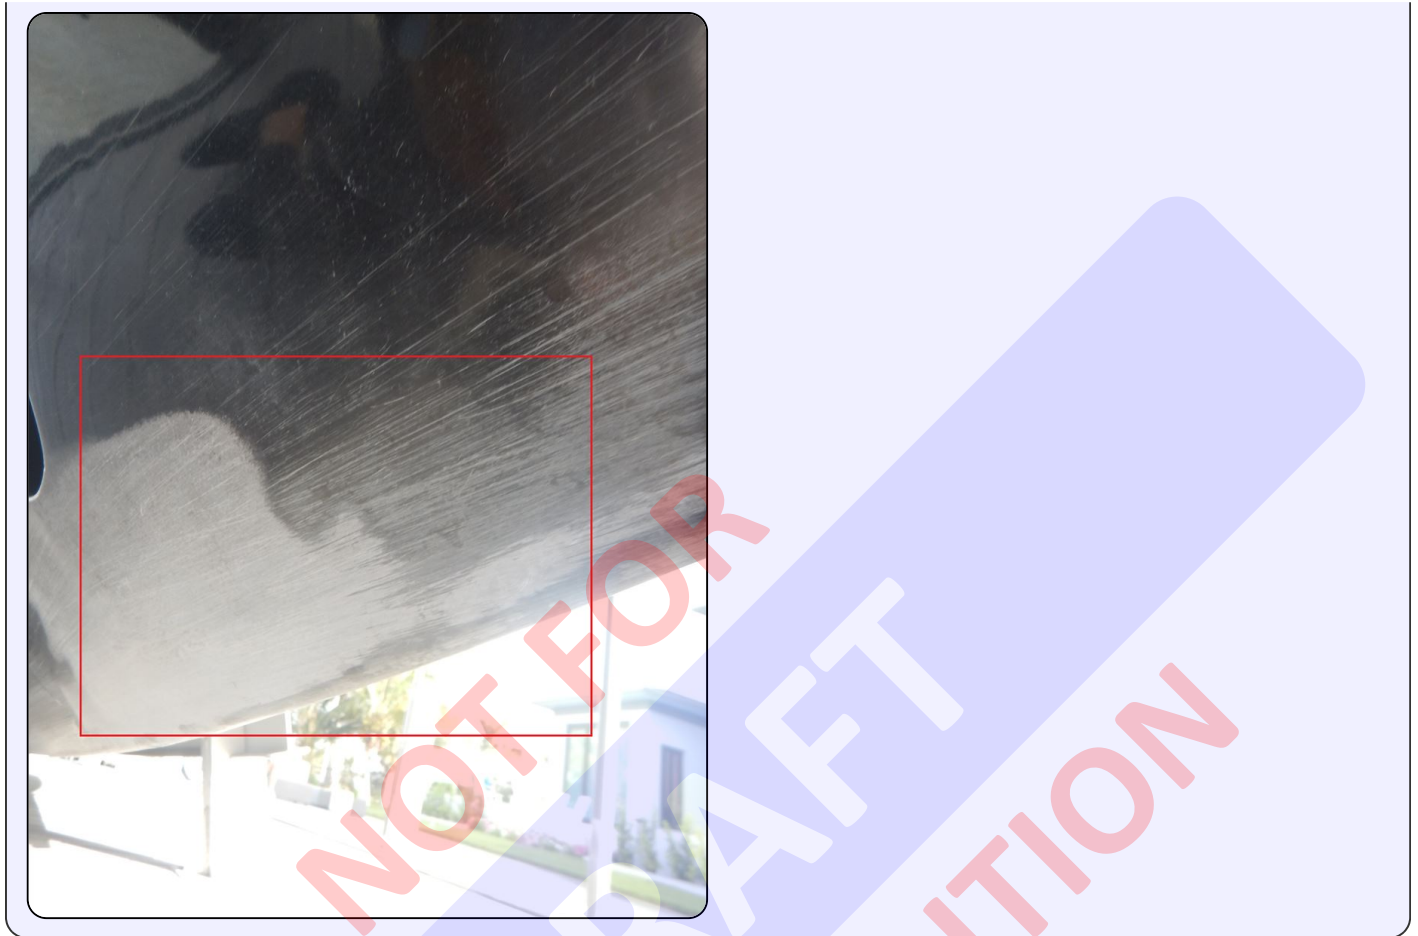
Gelcoat damage along keel from recreational beaching and or lift.

Investigate further with qualified fiberglass repair specialist and repair as indicated. Repair gelcoat damage if desired.

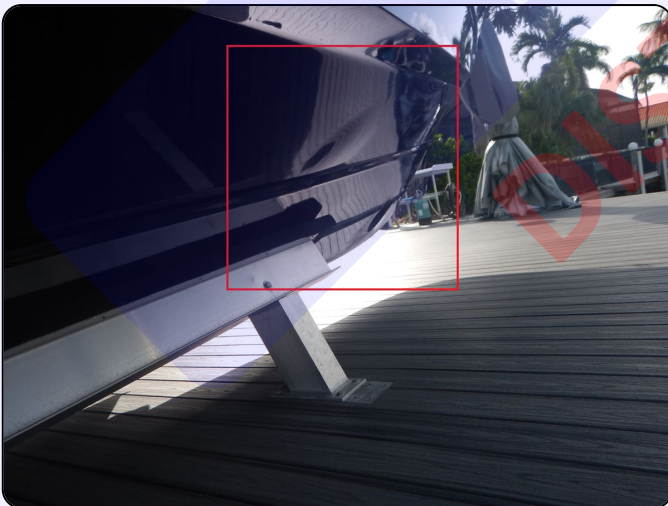
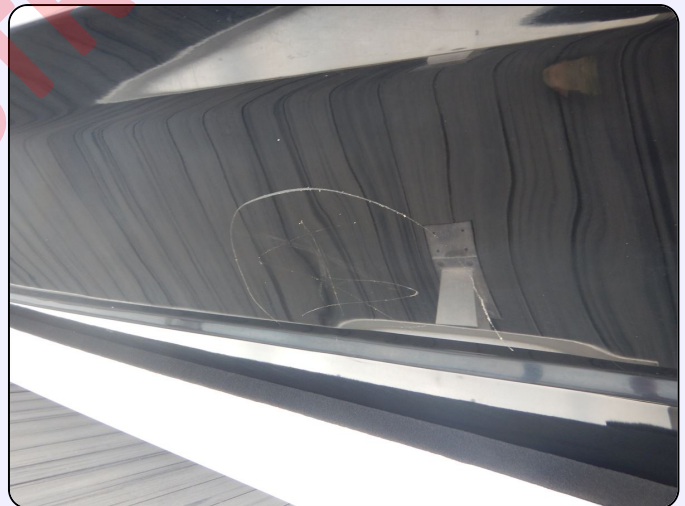
FINDING B-2 HULL, DECK & SUPERSTRUCTURE

Percussion sounding displayed results consistent with delamination and/or core saturation starboard forward running surface.

Investigate further with qualified fiberglass repair specialist and repair as indicated.

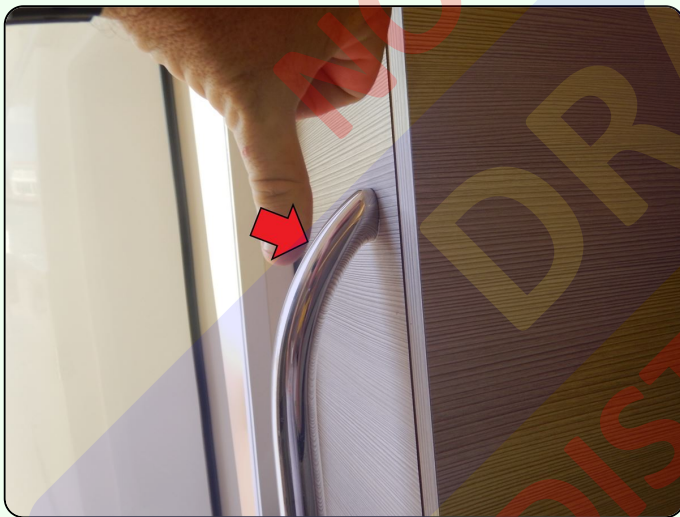
Grab rail for gangway coming into the center console is loose.

Investigate further.

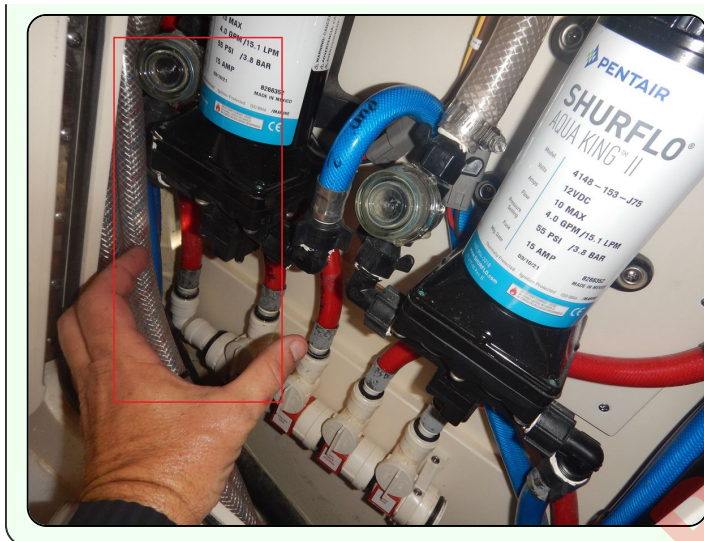
FINDING C-4 POTABLE WATER SYSTEM

Fitting or hose leaking when system is in use.

Investigate further and repair as indicated.
