Marine Survey Report For Mr. Mickey Mouse

"2022 Scout 425 LXF "

Date Of Survey: 7/23/2023

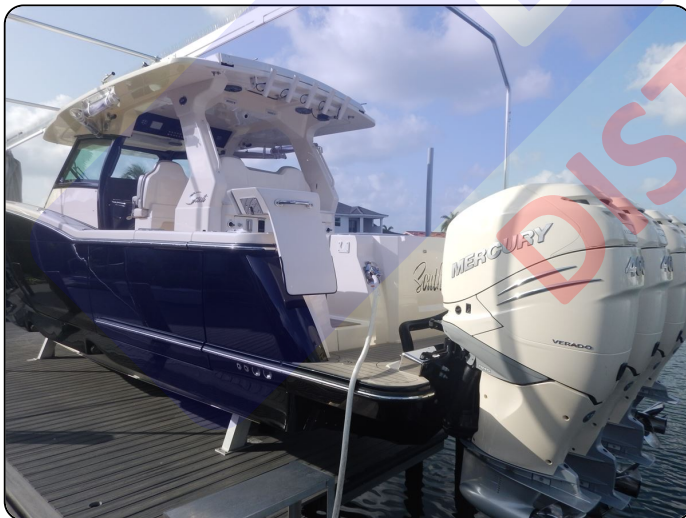
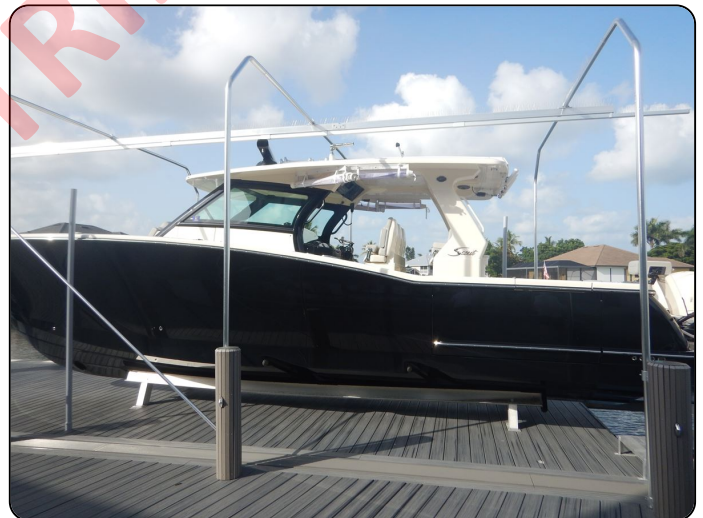
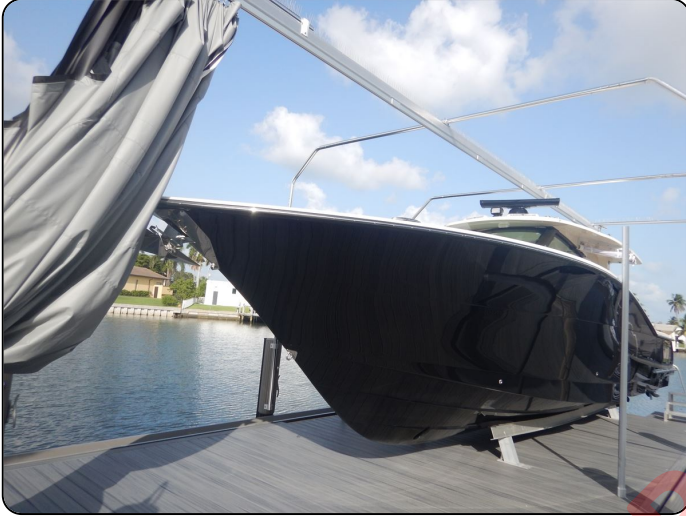
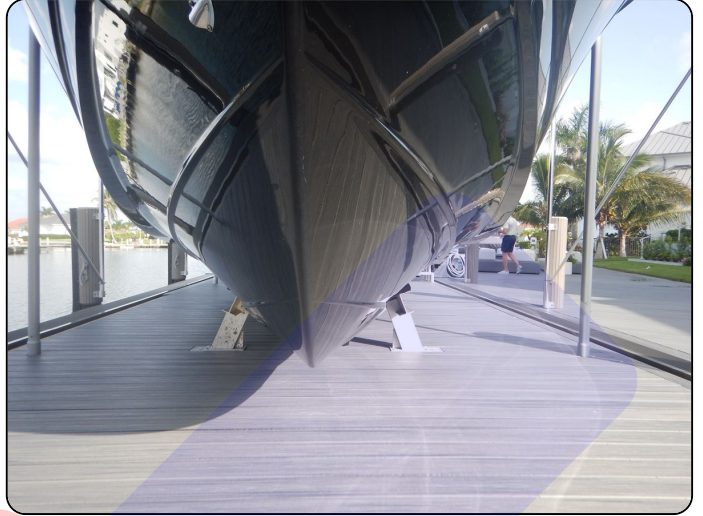
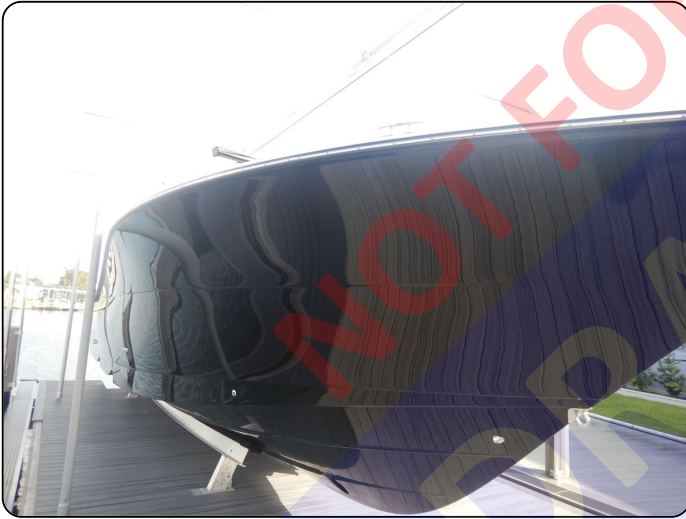
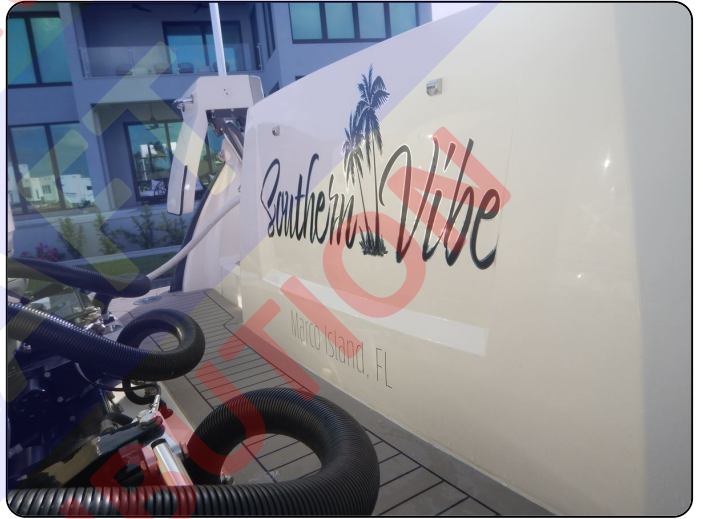
TRANSOM

Transom: The hull-deck joint is found to be well secured with no observed cracks or defects. Moisture readings indicate dry conditions, and no delamination is detected when checked with a percussion hammer.

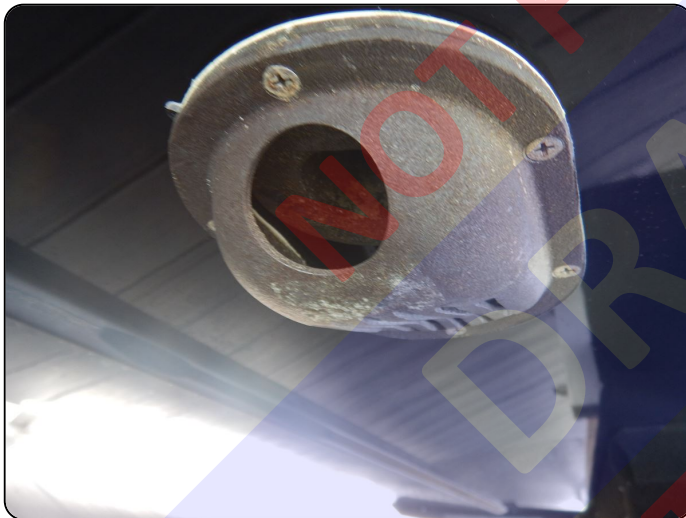
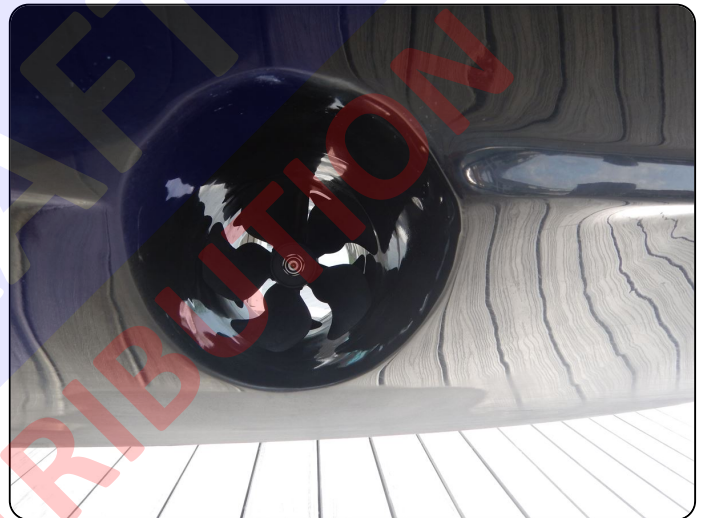
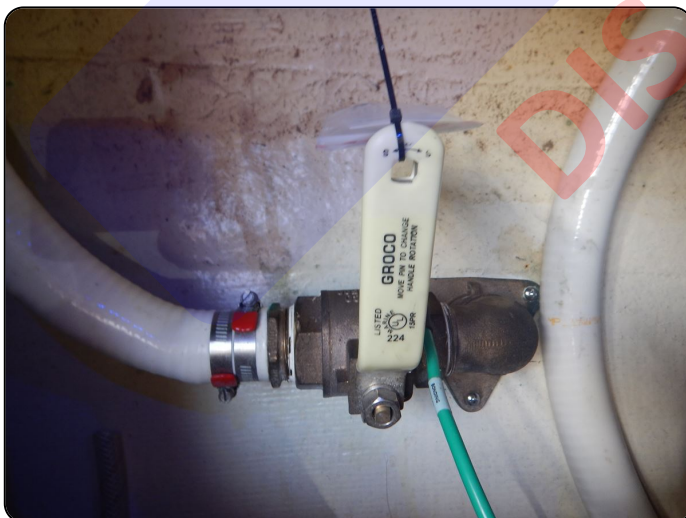
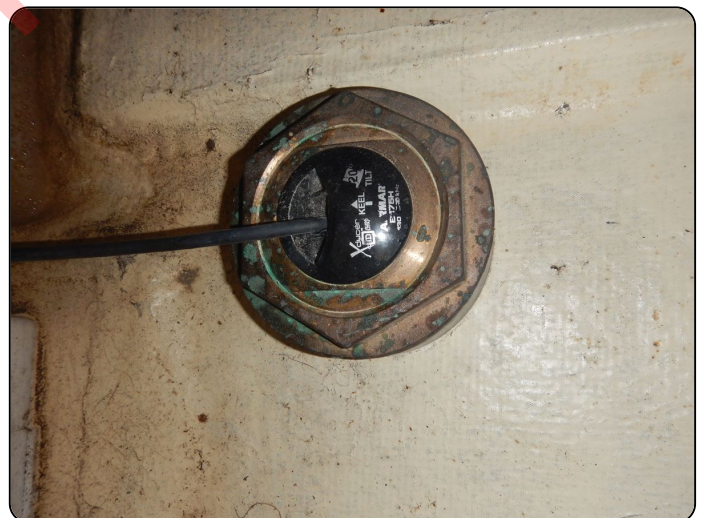
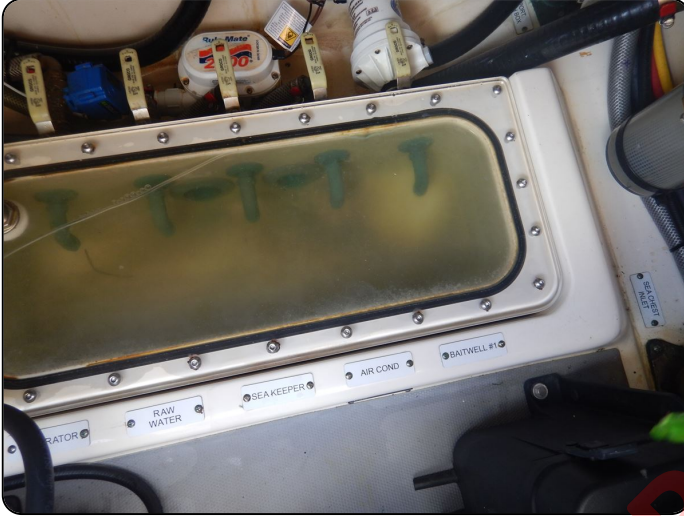
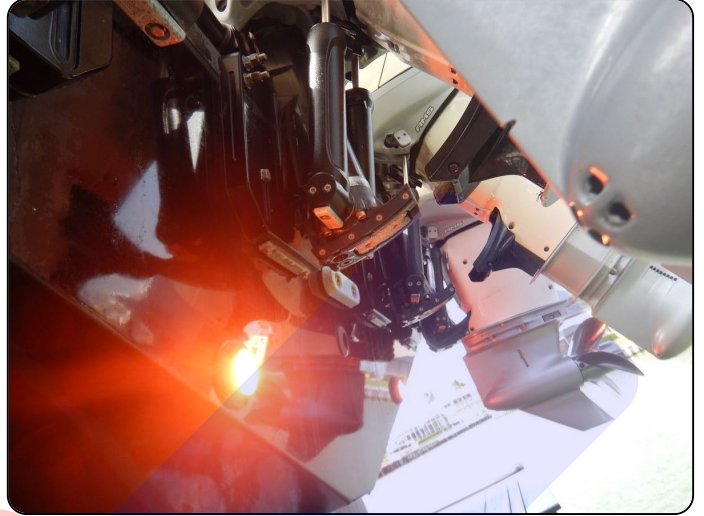
CONDITION & COMMENTS

In apparent serviceable condition except as noted in the Findings & Recommendations.

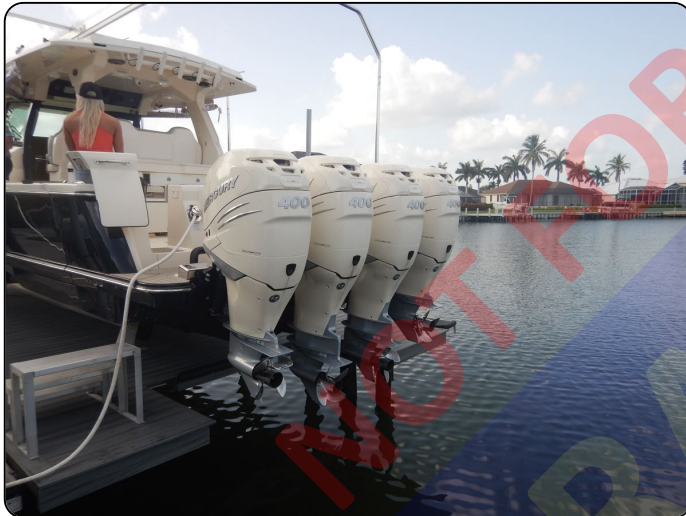
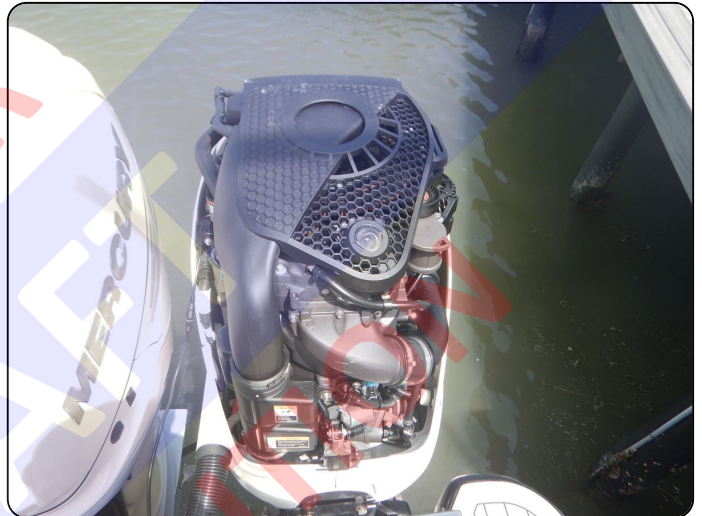
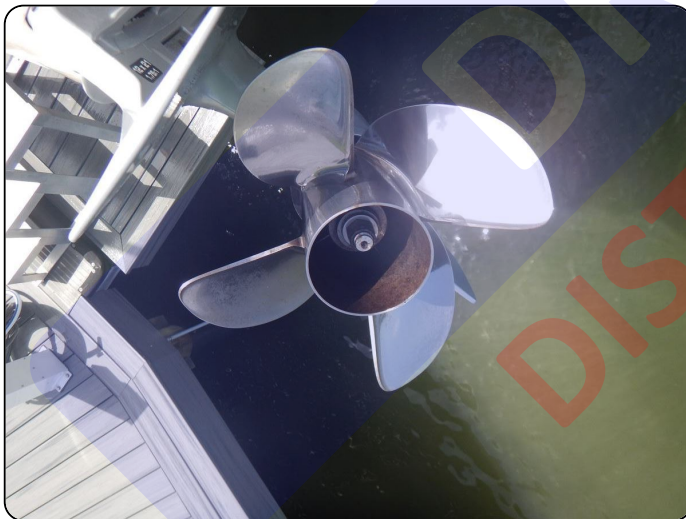
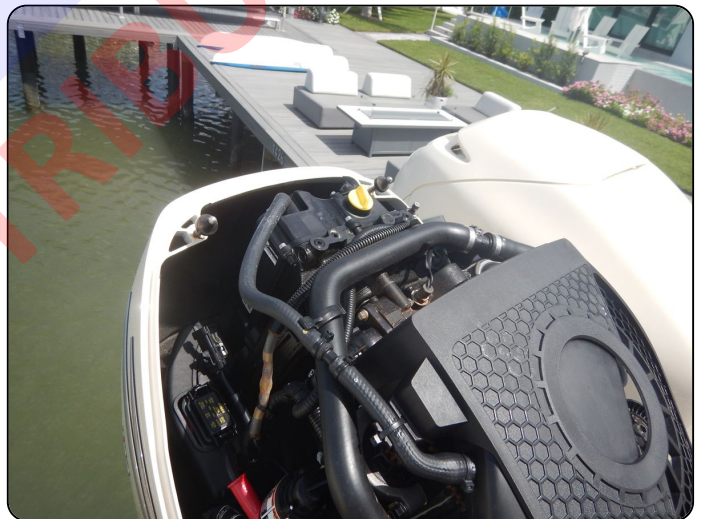
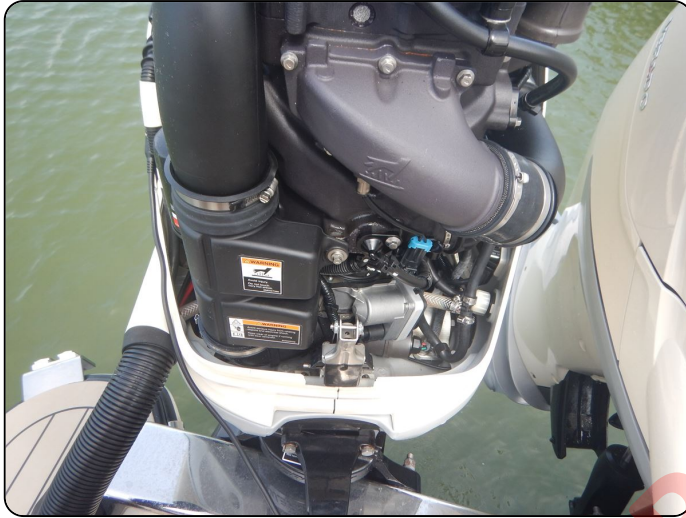
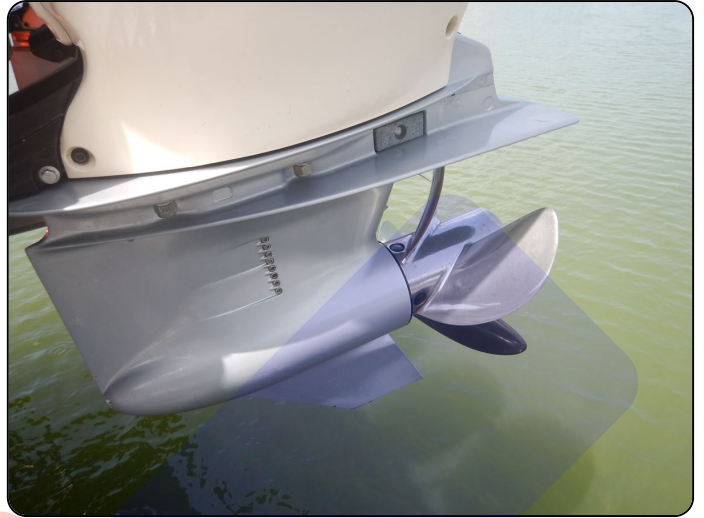
During the inspection, the engine mounts were found to be secure.

The cowlings of the outboard engines were in good condition, with no visible scratches or broken sides.

The props were stainless steel four-bladed Mercury REV4 props and showed no visible damage.

All skegs (the lower fin-like portion of the outboard) were in good condition.

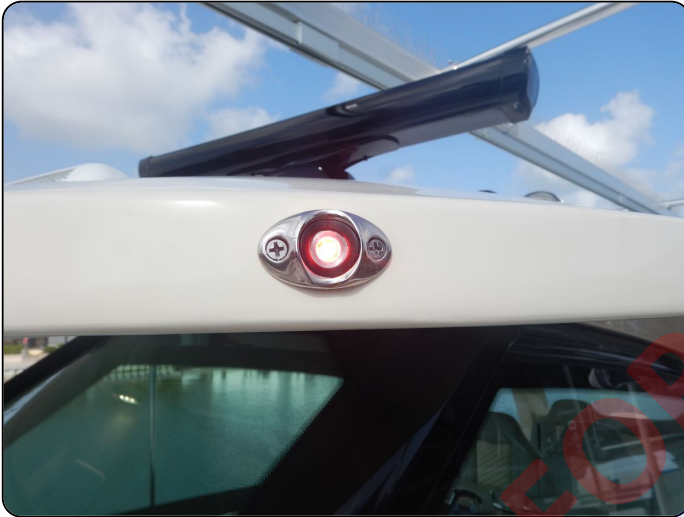
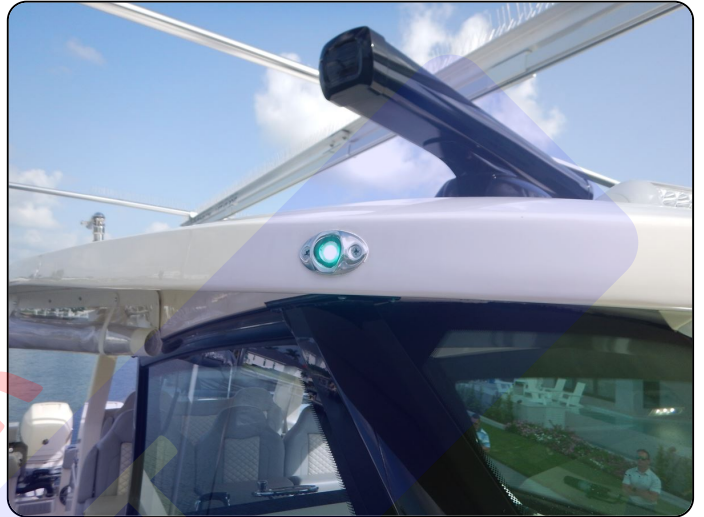
NAVIGATIONAL LIGHTS

All Navigation lights are fully operational.

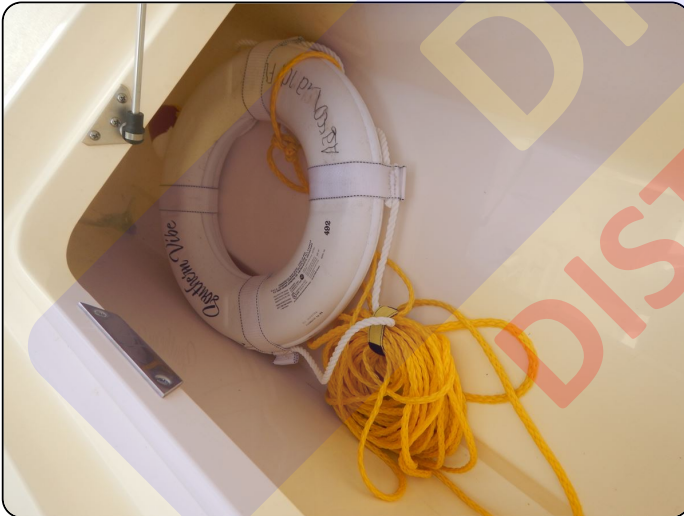
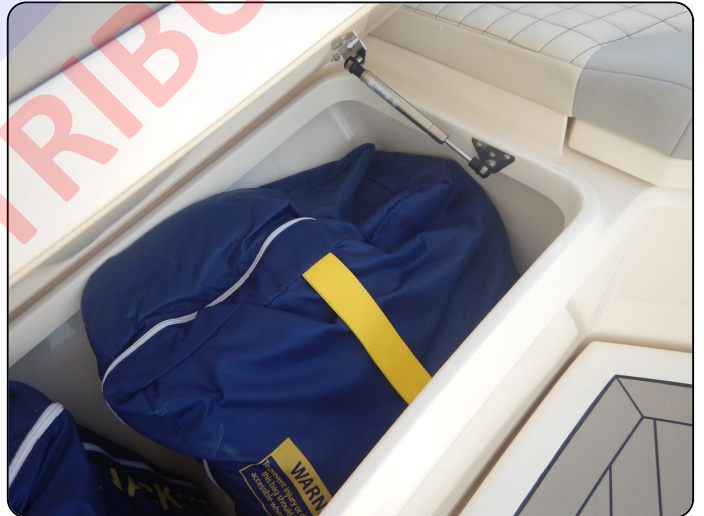
LIFE JACKETS (P.F.D,'S)

(8) U.S.C.G. Type II All appear to be in serviceable condition showing minimal wear and tear.

(1) USCG approved Ring buoy(s) All appear to be in good condition showing average wear and tear for the age of the vessel.

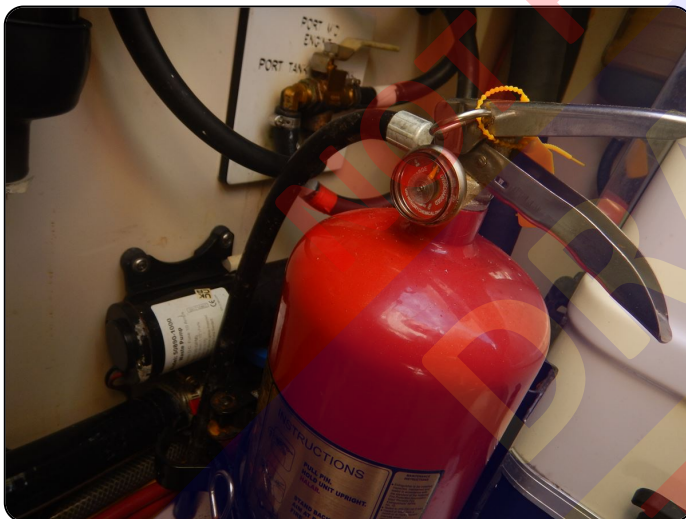
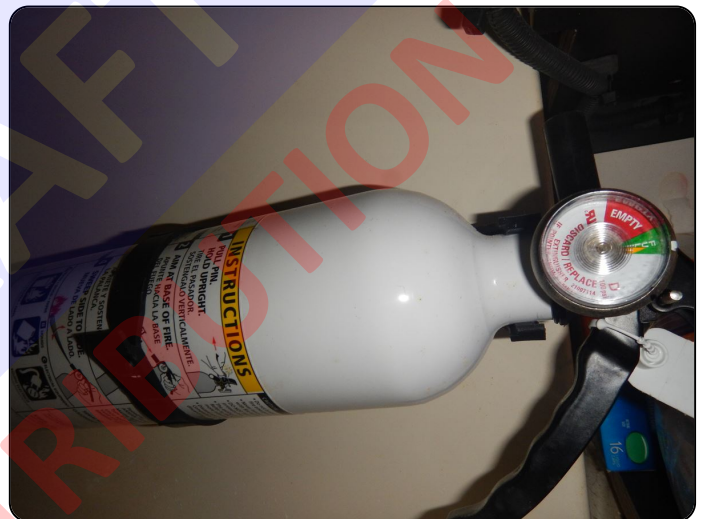
(3) Type I Fire-Boy extinguishers were sighted on the vessel in the galley, aft port quart, and near genset. Have portable fire extinguishers inspected per manufacturers specifications.

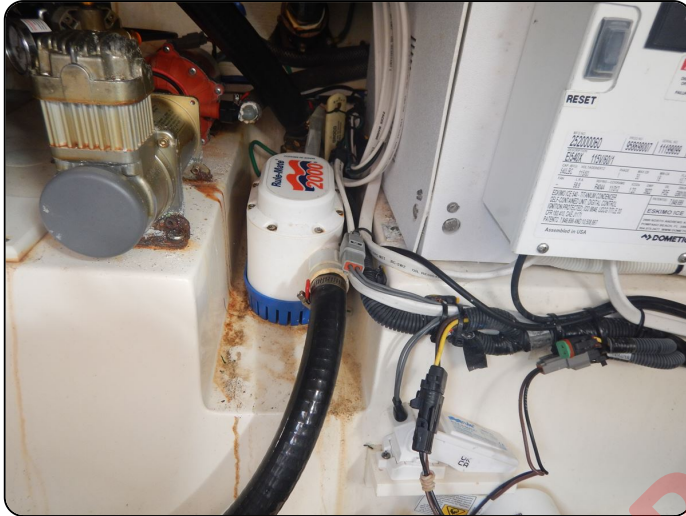
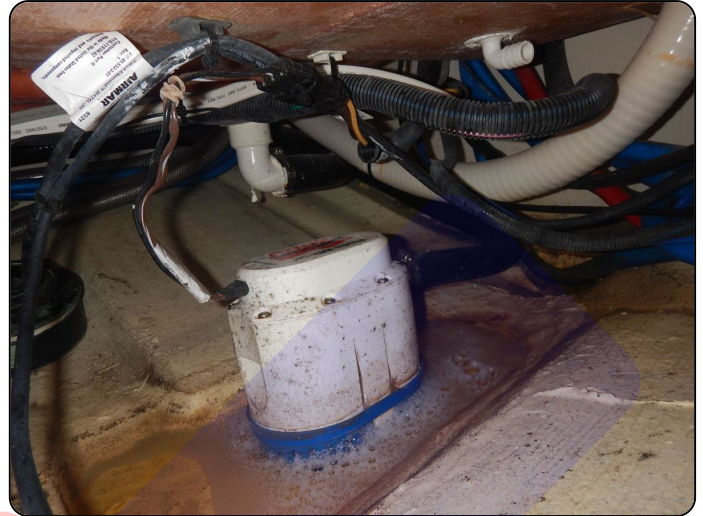
BILGE PUMPS

Aft Bilge: (2) Rule 2000 GPH, functional when tested.

Sump Tanks: Rule 500 GPH, functional when tested.

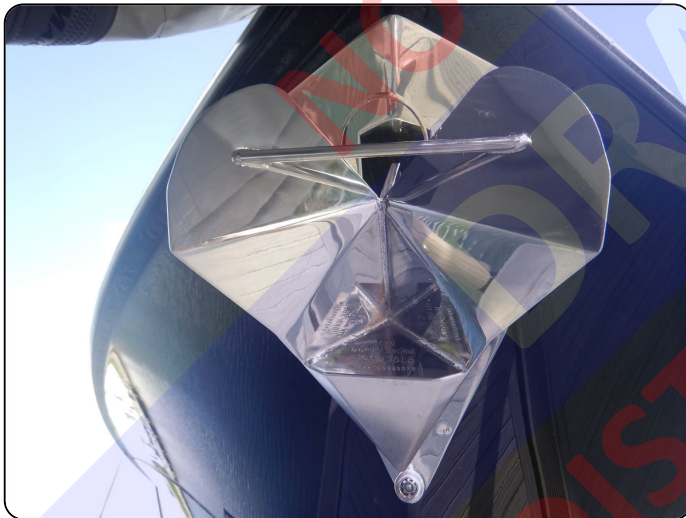
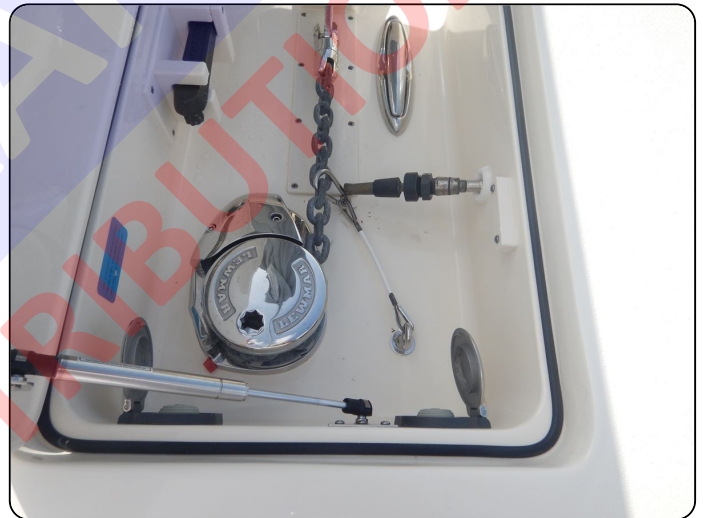
GROUND TACKLE & WINDLASS

Primary: A polished stainless steel Lewmar Delta style anchor is mounted at the anchor platform with an undetermined length of raw chain and considered serviceable other than noted in the Findings & Recommendations, showing moderate wear and wastage.

Windlass: A Lewmar windlass is mounted on the platform and was functional using both the helm and the bow foot controls.
